6. Examining the Financial and Non-Financial Case for Maintenance

6.2 Evolution of the survey pro-forma

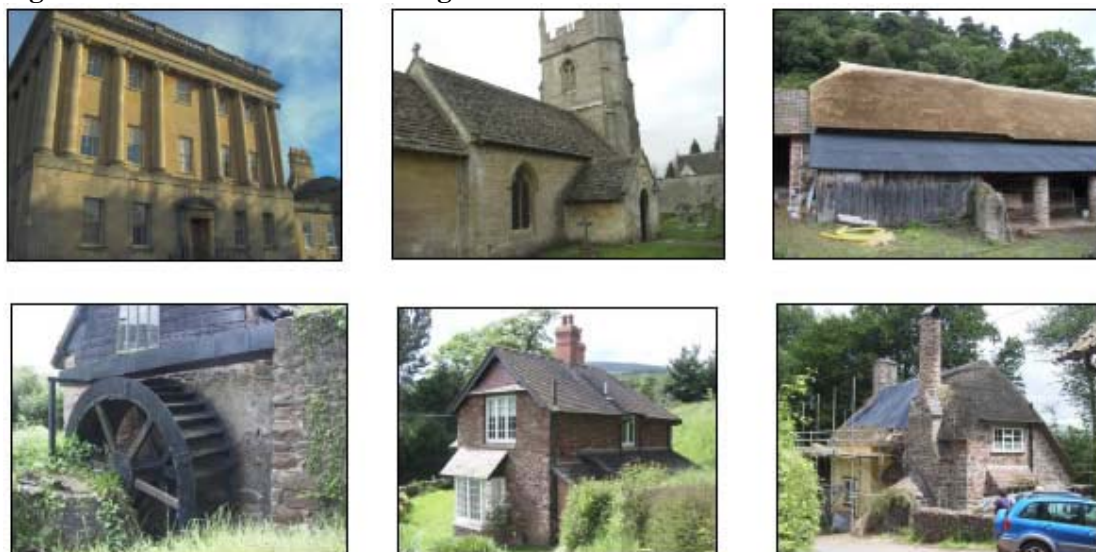
Six historic buildings were inspected (Figure 6.1). These were selected to represent a fairly wide spectrum of the UK's historic buildings.

Figure 6.1: The six historic buildings used in this research

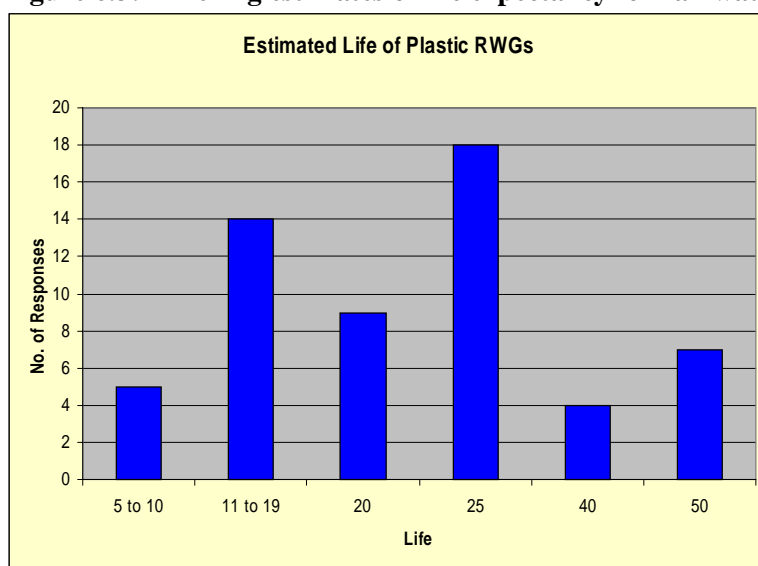
Figure 6.3 below shows a typical example - the expected life of plastic rainwater goods. The estimated life of new components ranges from 5 years to 50 years although the majority of responses indicated a life span of between 10 and 25 years.

Figure 6.3: Differing estimates of life expectancy for rainwater goods

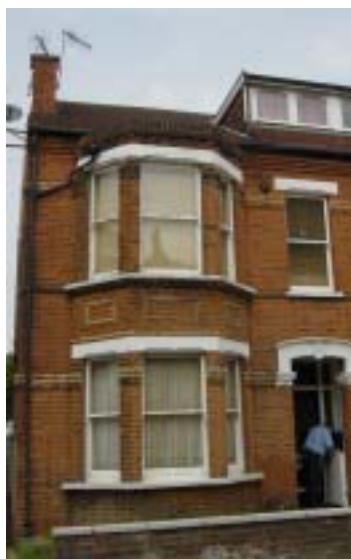
The photograph on the left shows a Victorian terraced house recently converted into four dwellings by a west London Housing Association. In June 2003 a new member of staff was asked to prepare a property profile, partly to aid long term strategic planning, and partly to identify a short term programme of repair and improvement works.

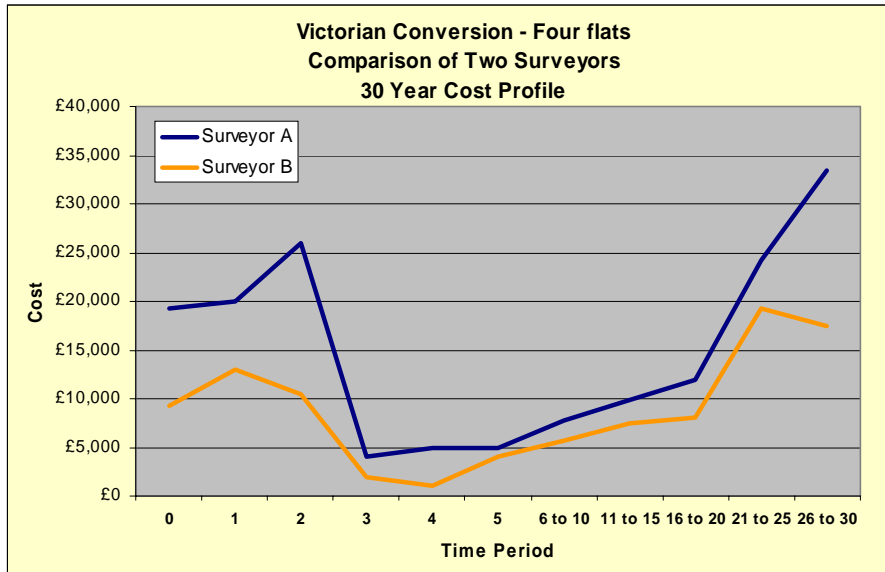
Figure 6.4: Comparative 30 year maintenance profiles

A second surveyor, with extensive experience in managing repairs and improvement programmes, and with knowledge of local contractors, produced a second profile (see Table 6.6 below). The annual amount per dwelling of £812 was still higher than the budget (£750) but of much more use to the organisation. A property profile which does not take into account the available resources may be of use for long term strategic planning, lobbying or grant applications, but it is of limited use for operational management.

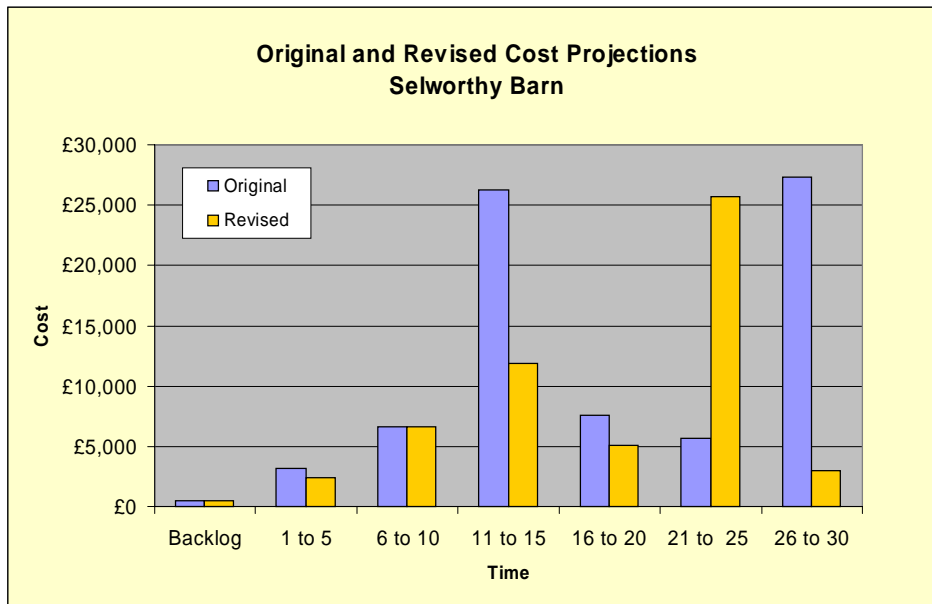
A comparison of the two profiles (in blocks of 5 years) can be seen in Figure 6.6 (overleaf). The effect of the revised projection has been to reduce the cost, and to delay it. In this instance additional inspections may be necessary to minimise the risk of premature failure.

Figure 6.6: A comparison of the original and optimistic Selworthy Barn property profiles
